DEPARTMENT OF TRANSPORTATION

Contract #: 04-0120F4Cty: SF/ALA Rte: 80 PM: 13.2/13.9File #: 69.28**WELDING INSPECTION REPORT****Resident Engineer:** Siegenthaler, Peter**Address:** 333 Burma Road**City:** Oakland, CA 94607**Report No:** WIR-025651**Date Inspected:** 24-Jul-2011**Project Name:** SAS Superstructure**OSM Arrival Time:** 1900**Prime Contractor:** American Bridge/Fluor Enterprises, a JV**OSM Departure Time:** 700**Contractor:** Zhenhua Port Machinery Company, Ltd (ZPMC), Changxing Island **Location:** Shanghai, China

Summary of Items Observed:

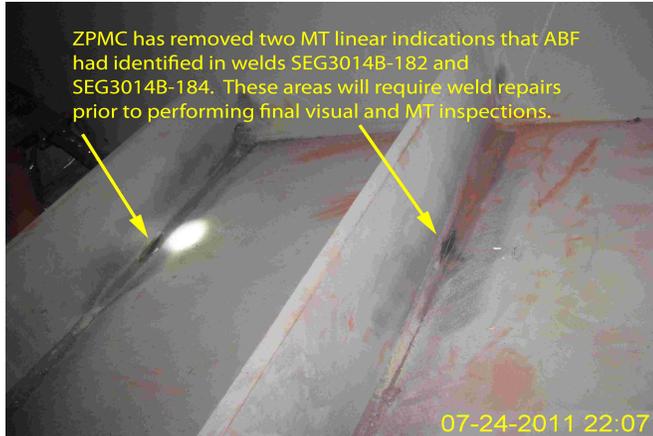
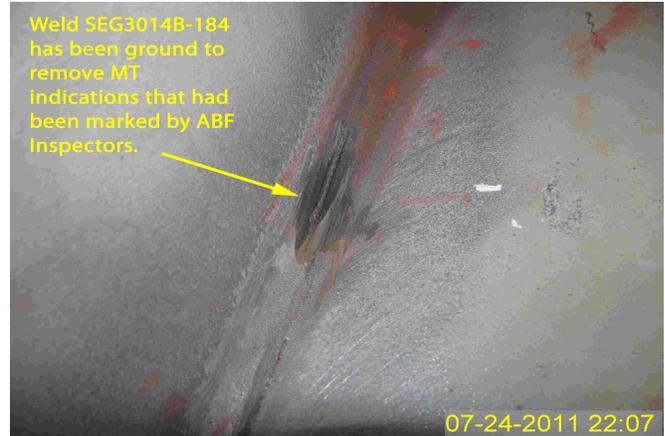
Caltrans and ABF have agreed to conduct visual and magnetic particle inspections (MT) of segment 13 West welds as part of a special inspection program, reference NWIT 9805. This QA Inspector observed ABF Inspectors had completed and accepted MT inspections of welds: SP3143A-001-071, 072, 073, 074, 075, 076, 077, 078, 079, 080, 081, 082, 083, 084; SP3142C-001-139, 140, 141, 142, 143, 144, 145, 146, 147, 148, 149, 150, 151, 152; SP3141B-001-180, 181, 183, 185, 186, 187, 188, 189, 190, 191, 192, 193; SP3140B-001-117 and 118. ABF Inspectors rejected welds: SP3141B-001-182 and 184. ZPMC workers performed welding and grinding of these two welds. This QA Inspector performed random visual and magnetic particle inspection of welds: SP3143A-001-074, 075, 076; SP3142C-001-142, 143, 144, 145, 146; SP3141B-001-185, 187, 192, 193; SP3140B-001-117 and 118 and these welds appear to comply with AWS D1.5 MT and visual requirements. For additional information on these inspections see this QA Inspector's TL6028 Magnetic Particle Test Report. See the photograph below for additional information.
